NATIONAL ADVISORY COMMITTEE FOR AERONAUTICS.

CAUSES OF FAILURE OF AIRSHIP SHEDS.

I. COLLAPSE OF AIRSHIP SHED A IN NIEDERGORSDORF.

II. SUCTION EFFECTS OF WIND ON ROOF OF AIRSHIP SHED

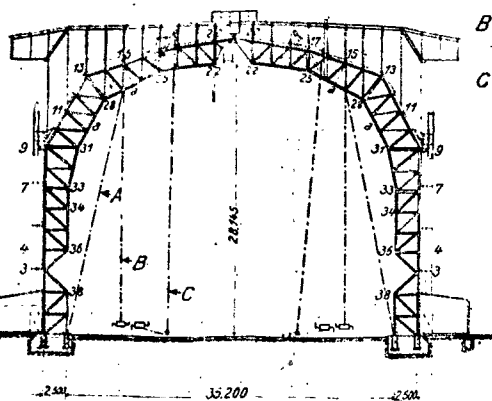
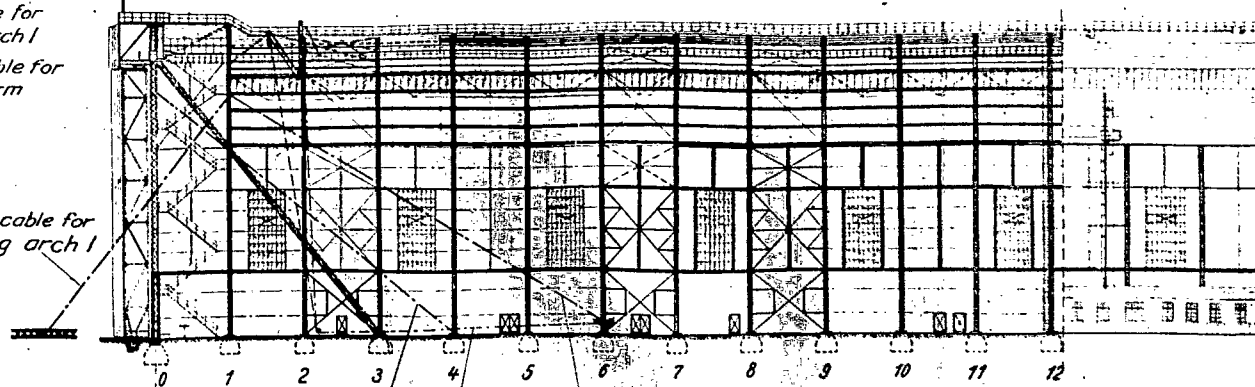
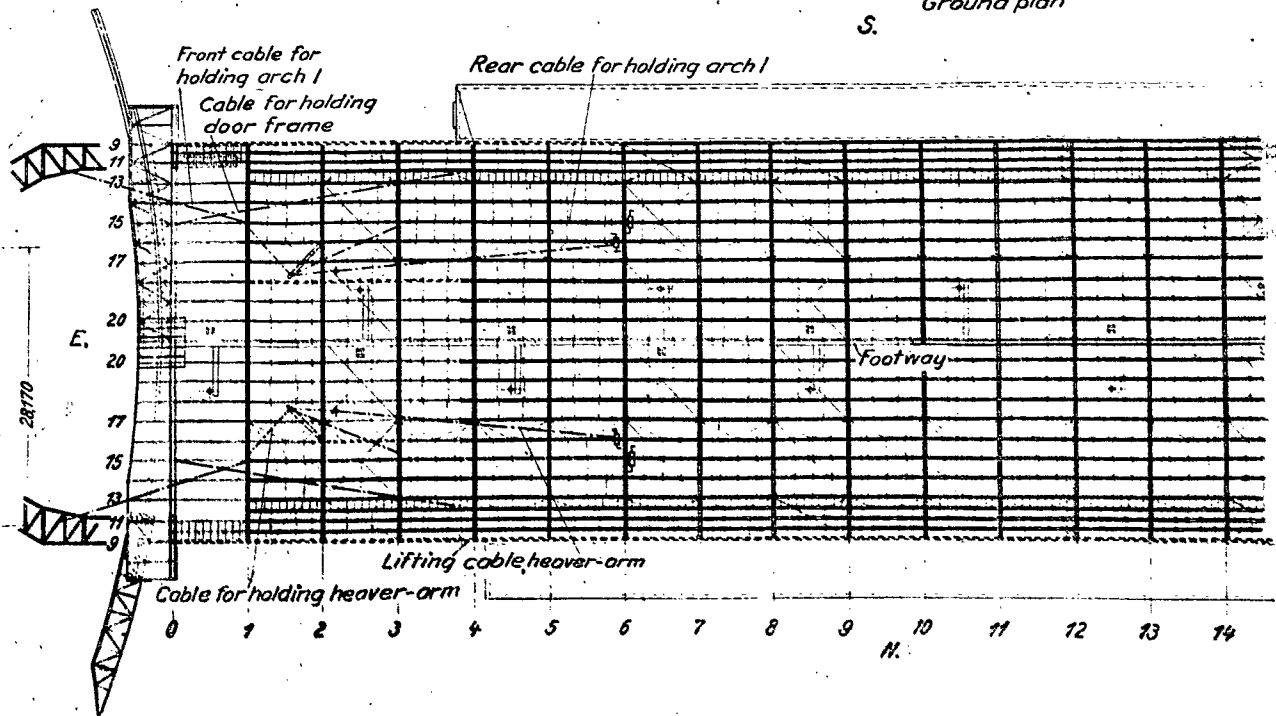
The roof covering had been partially removed. The roof supports were three-jointed arches with ridge-pole joint and buttress joints. Fig. 1 shows all the structural parts which had not been removed at the time of the collapse. There had already been removed both end-doors and guides, all supports between purlins 9 and 9, and the longitudinal brace in the side walls as far back as arch 7 and in the rear as far forward as arch 17. Under the roof covering, between arches 2 and 3, the cross-braces between purlins 17 and 17 had been removed and it is highly probable that all of them had been loosened. Of the

longitudinal girders between the upper and lower arches, all the upper members between purlins 13 and 13 had been loosened and the lower members were mostly bent and twisted by the weight of the upper members which, with their braces, were tilted and hanging sidewise. Lastly, the ridge-pole and the footway under it had been removed to about the middle of the shed, so that the ridge joint was no longer braced laterally. The buttress joints still held, because the walls below them were lined with masonry and the stays had not been removed.

In the condition shown in Fig. 1, all the arches had been detached to such an extent that their security was endangered. Relatively small eccentricities of the columns or spans or of the lateral forces could have easily caused them to break down. A strong gust of wind would have perhaps sufficed. The most endangered points, namely the top ends of arches 1 to 3, were subjected to considerable additional stresses, since heaver-arms were attached to the side of arch 2 for lowering the pur-

lins. These arms must have exerted bending stresses on the arches, the effects of which would increase, as more purlins were removed. One of the men, who was working on a heaver-arm after most of the purlins had been removed, escaped with his life, though not without severe injuries. He remembered that the top of arch 2, just before the collapse bent toward the end of the shed. This arch, in falling, brought down the others with it.

On south side, braces 20-22 and 17-25 entirely removed
 " north " " 20-22, 17-25 and 15a "
 " south " at 15-a, upper braces loosened
 " " " 13-28, top member "
 " north " " 13-28, " " "

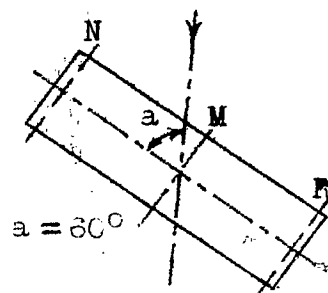
Fig.2 Air pressure distribution on model of airship shed, according to Eiffel. Plate XXXI of Atlas

without. The Staaken shed, in fact, had air-pressure, equalizing valves, but their effect was insufficient. Plate XXIX of Eiffel's Atlas (Fig. 2) gives wind-pressure distribution diagrams, which may be used here for comparison.

Fig. 2 shows the distribution of the pressure on the middle section and on the front gable wall of a shed model, created by an air stream with a velocity of 40 m/sec striking it at an angle of 60° . Toward the gable wall, on the windward side of the roof, the negative pressure decreases somewhat, though the manner of distribution is not changed.

It is seen that the location of the plates blown off is at the point of greatest suction and that their weight per square meter corresponds to the negative pressure in the Eiffel diagram. We may therefore conclude that the wind had a velocity of about 40 m/sec at the time of the disaster.
